**THIRD FIVE-YEAR REVIEW
FOR THE
SOUTH CAVALCADE STREET SUPERFUND SITE
HOUSTON, HARRIS COUNTY, TEXAS**

September 2012

Prepared by:
REGION 6
UNITED STATES ENVIRONMENTAL PROTECTION AGENCY
1445 Ross Avenue
Dallas, TX 75202-2733

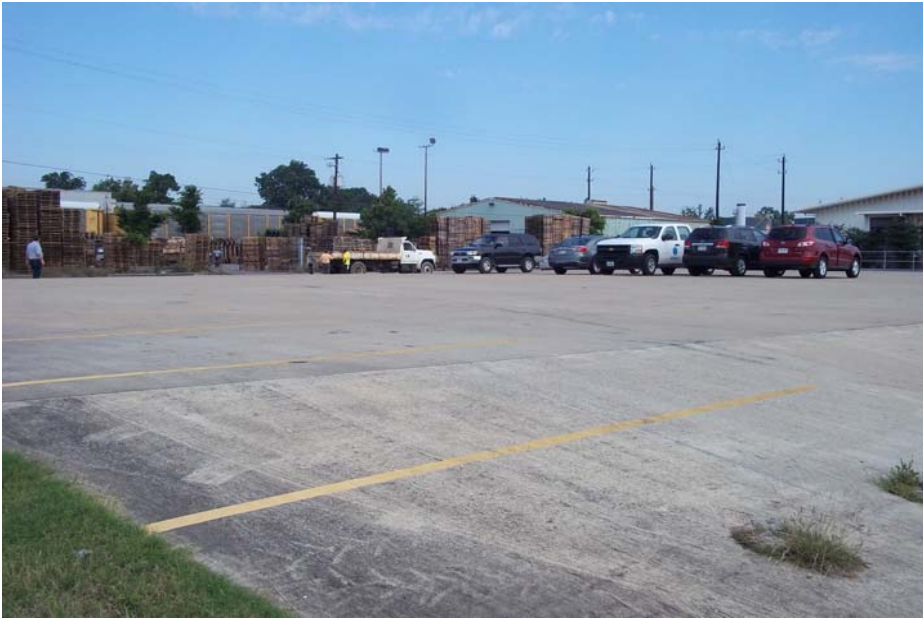
Photo 1. Southern area. Looking northwest at the southwest cap from the southeast corner. The cap is in good condition.

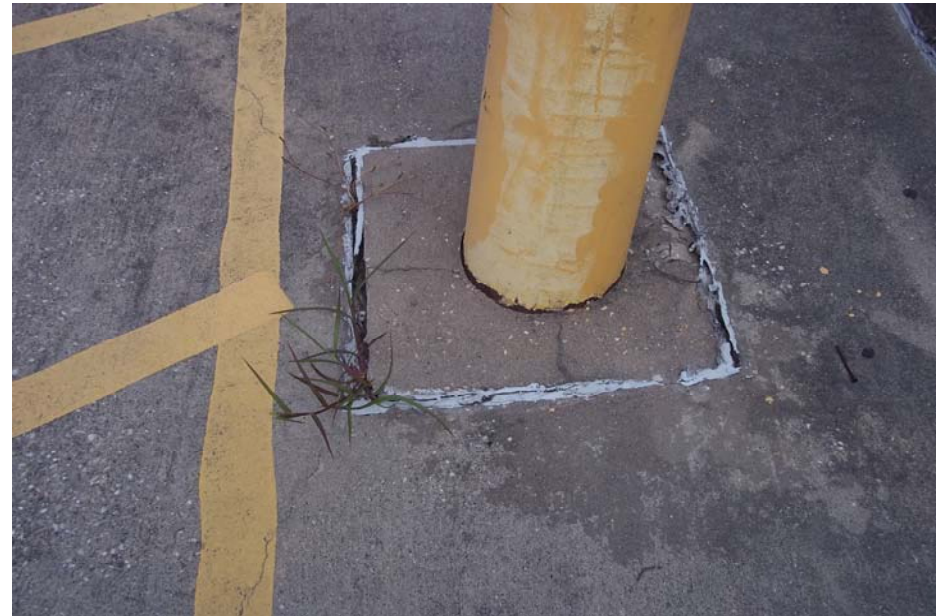
Photo 4. Southern area. The base of the bollard at the manhole cover needs to be re-caulked.

The concrete caps in both the southeast and southwest were in good condition (see photographs Attachment 4). Minor surface cracks were observed which are believed to be associated with the curing of the concrete. These cracks should be monitored for any significant changes over time. Minor weed growth was observed in some of the joints in the southeast cap, which should be removed. A 1/4 to 1/2 inch crack at the eastern portion of the southeast cap was observed that had been identified in previous Site inspections. This crack should be sealed with caulk. One joint near the eastern edge of the southeast cap has a noticeable gap, and should be re-caulked. The caulking at the base of one bollard at the southwest cap has a noticeable gap, and should be re-caulked.

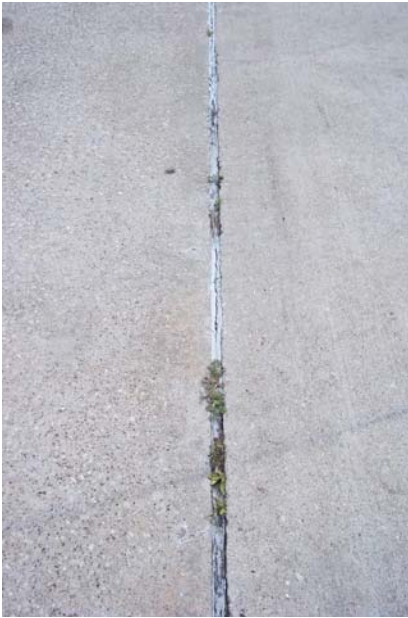
Photo 5. Southern area. Typical joint caulking in the southwest cap.

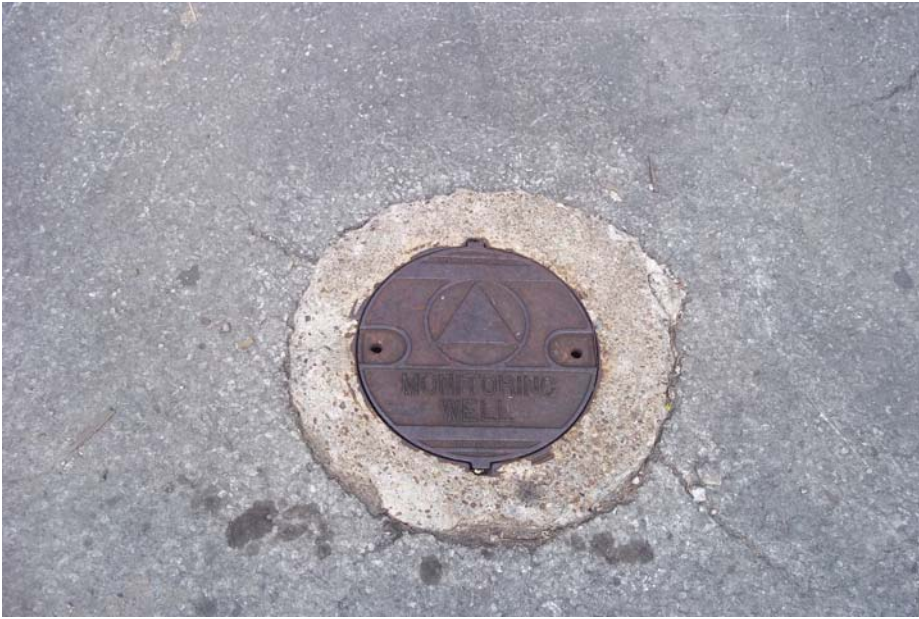
Photo 6. Southern area. Unlabeled well near MW-11 west of the southwest cap.

10. All wells should be inspected to evaluate their condition. The wells should have caps, locking protective casing lids, labels, and sound well pads. Lost wells should be located, and damaged and inoperable wells should be evaluated for usefulness and either plugged and abandoned or replaced.

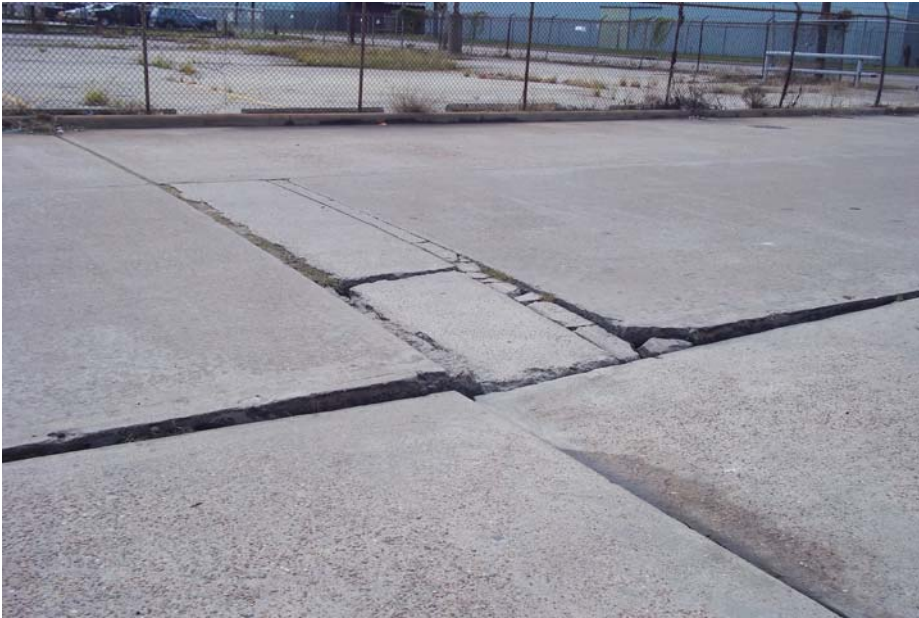
An offset in the pavement was observed just to the east of the eastern edge of the southwest cap and may have been the result of a washout created when the water supply line broke during

2000-2001 timeframe. The offset appears to be the same as observed in the 2002 and 2007 Five-Year Reviews. This offset in the concrete is not on the cap and does not appear to have impacted the integrity of the cap or the protectiveness of the remedy. The eastern edge of the southwest cap should continue to be monitored for impacts from a historical water line break.

Photo 8. Southern area. Driveway just east of the southwest cap with an offset at the joint.

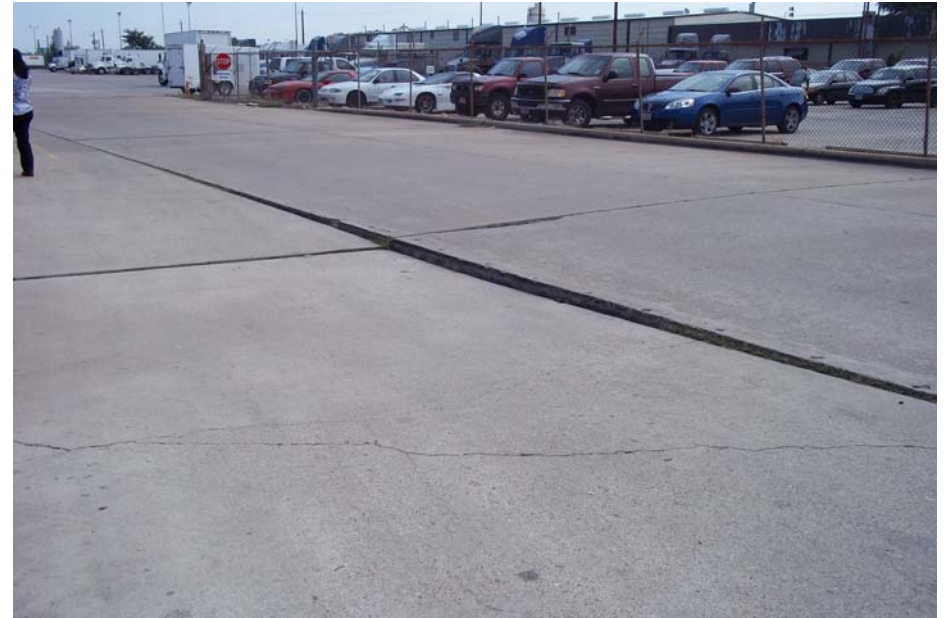
Photo 9. Southern area. Offset in the driveway along the joint just north of Photo 8.

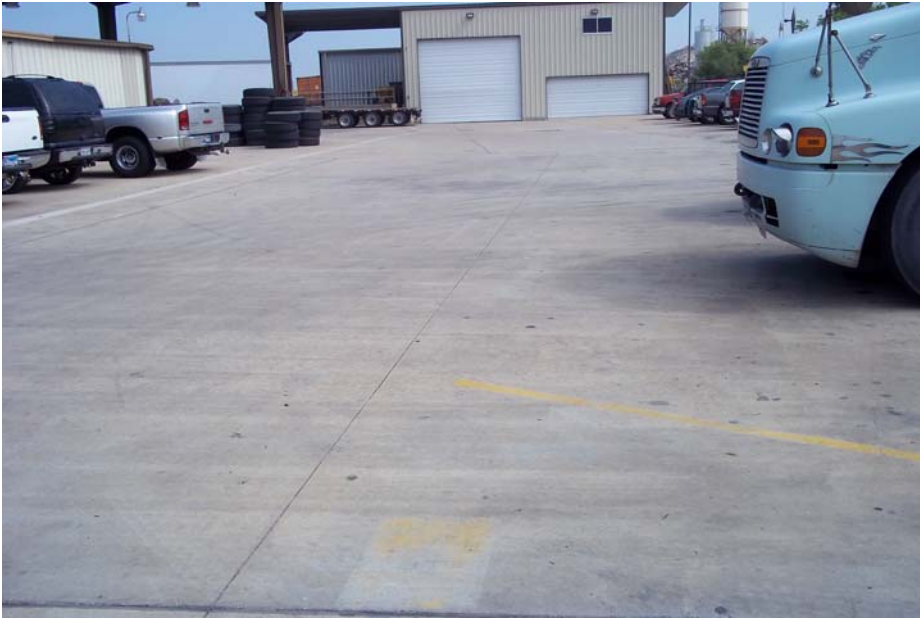
Photo 11. Southern area. Looking north from the south edge of the southeast cap. The cap is in good condition.

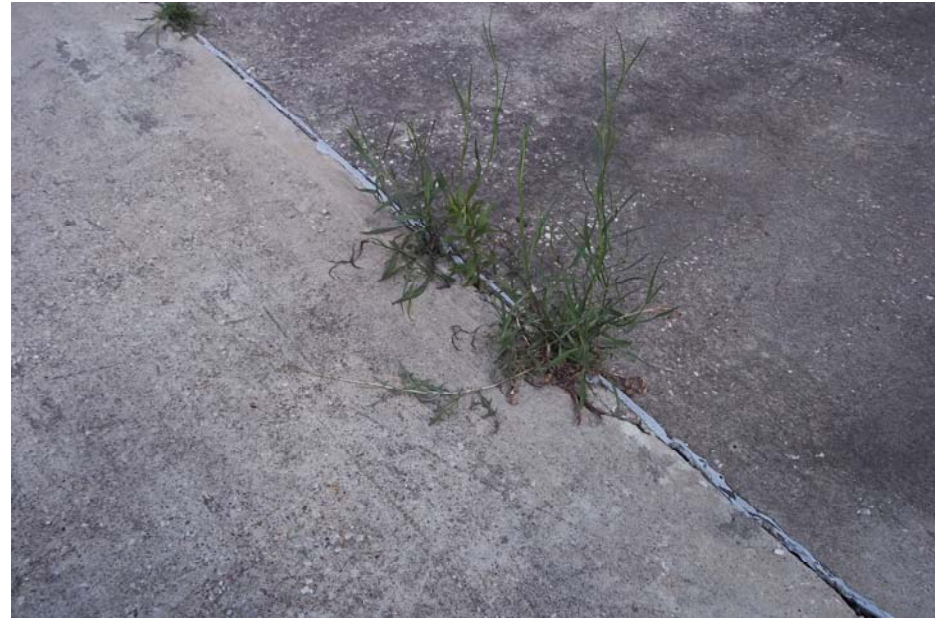
Photo 12. Southern area. Weeds growing out of the caulked joint near the east edge of the southeast cap, at the southeast corner of the building in the cap.

1. The property owners should inspect and maintain joint systems and repair cracks and joint systems as required. Beazer is responsible for continuing annual cap inspections.

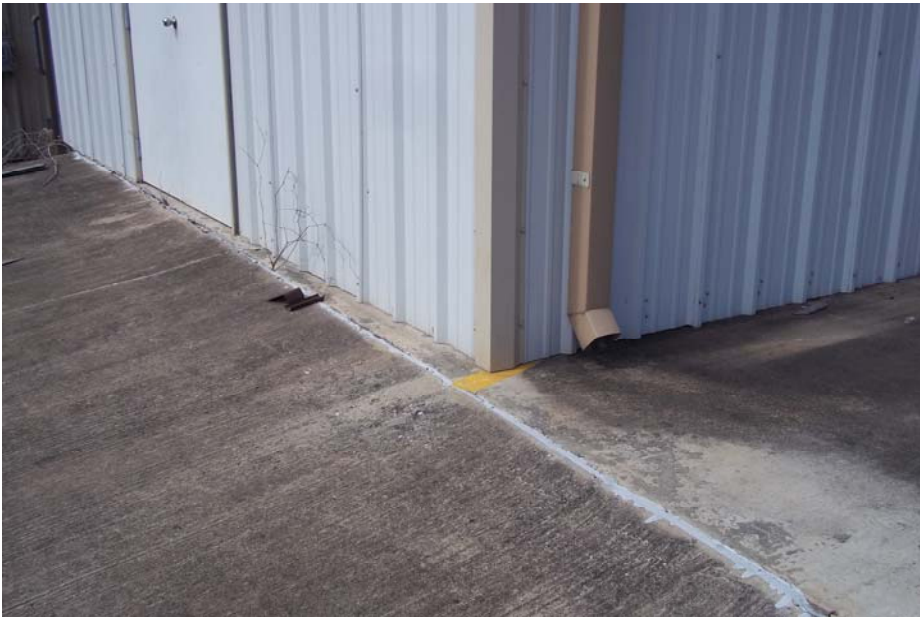
Photo 13. Southern area. A new building was built on top of the southeast cap in 2009.

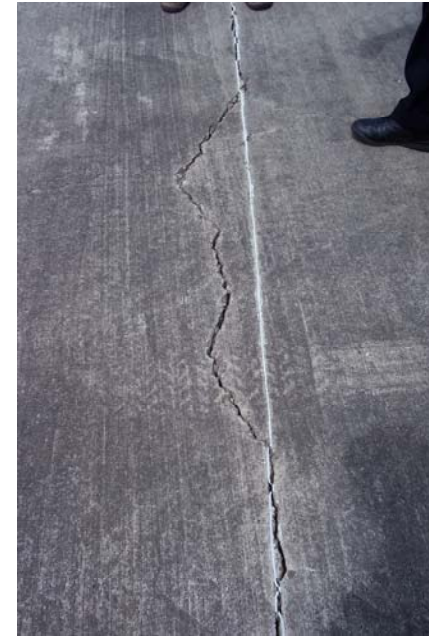
Photo 16. Southern area. Crack near the east edge of the southeast cap.

- Monitor the eastern edge of the southwest cap for impacts from a historical water line break.
- Monitor the surficial cracks (from curing) in the caps for any significant changes over time.
- Seal the observed crack in the southeast cap.
- Re-caulk the gaps at the base of the bollard in the southwest cap, and the joint in the southeast cap.
- Inspect all wells and perform maintenance and repairs as necessary.

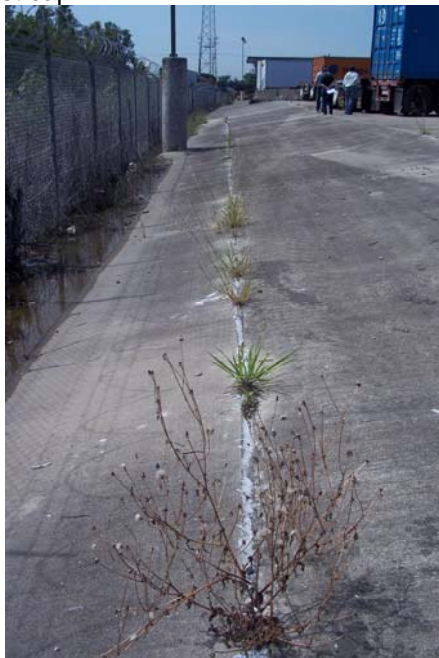
Photo 17. Southern area. Weeds growing out of the caulked joint along the east edge of the southeast cap.

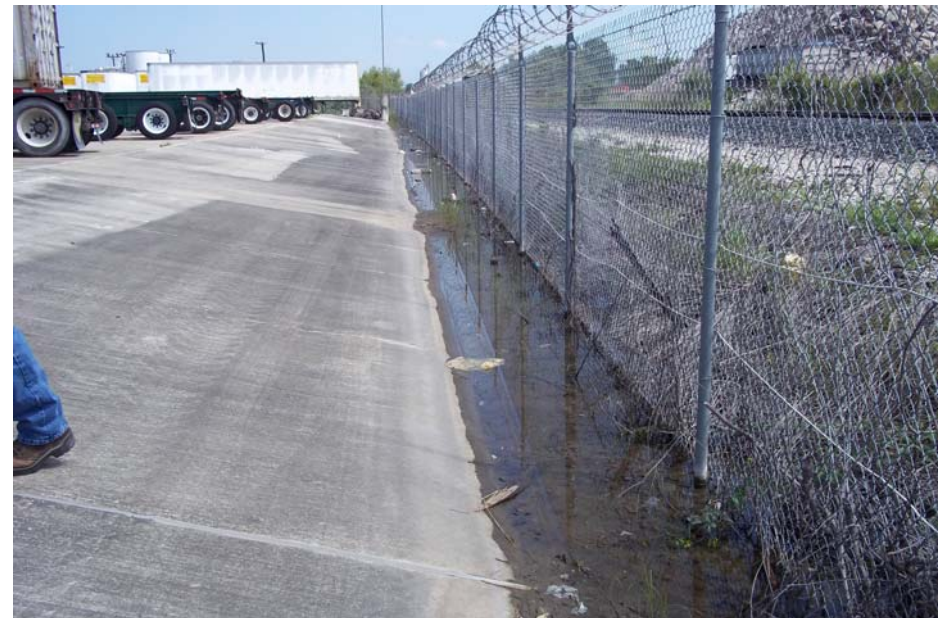
Photo 18. Southern area. Water stands in the ditch along the east edge of the southeast cap.

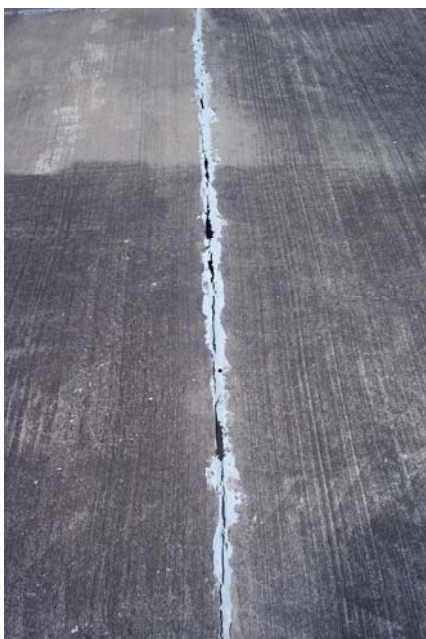
Photo 19. Southern area. Along the east edge of the southeast cap, a joint with a gap in the caulking that needs to re-caulked.

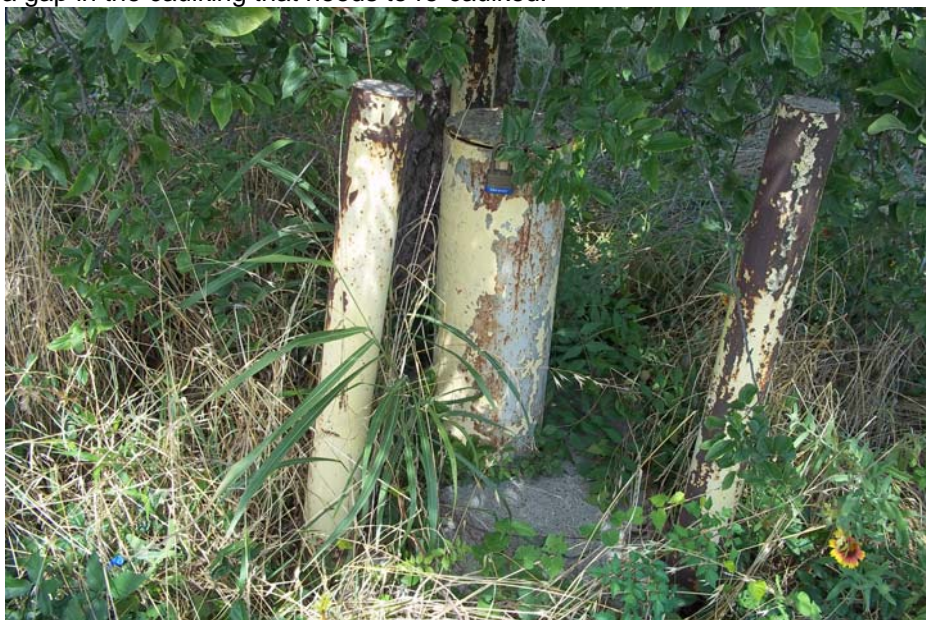
Photo 21. Northern area. Unlabeled well north of OW2.

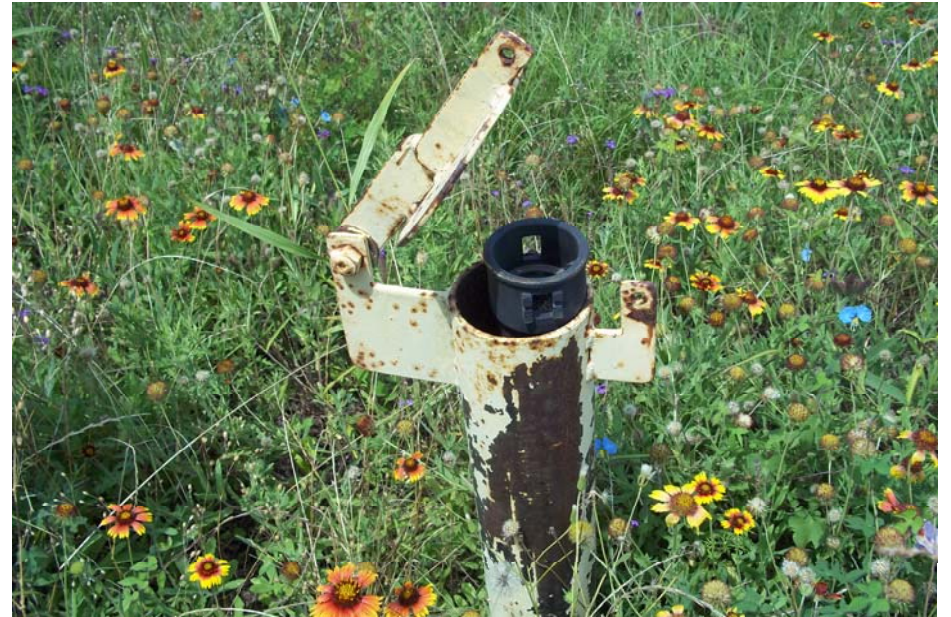
Photo 24. Northern area. Unlabeled well adjacent to well labeled PTZ-2 is missing the well casing cap.

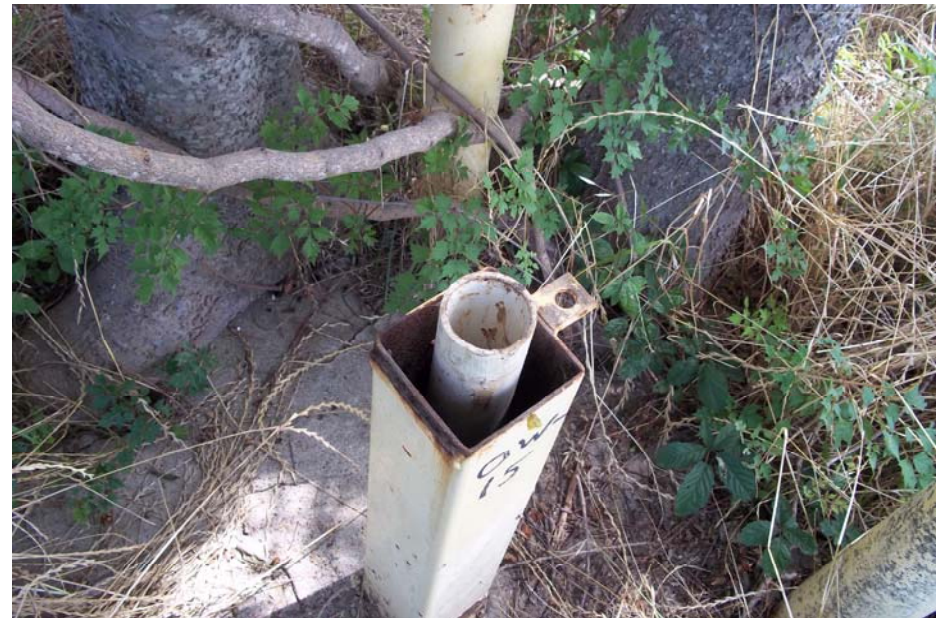
Photo 26. Northern area. Well OW-15 is missing the well casing cap.

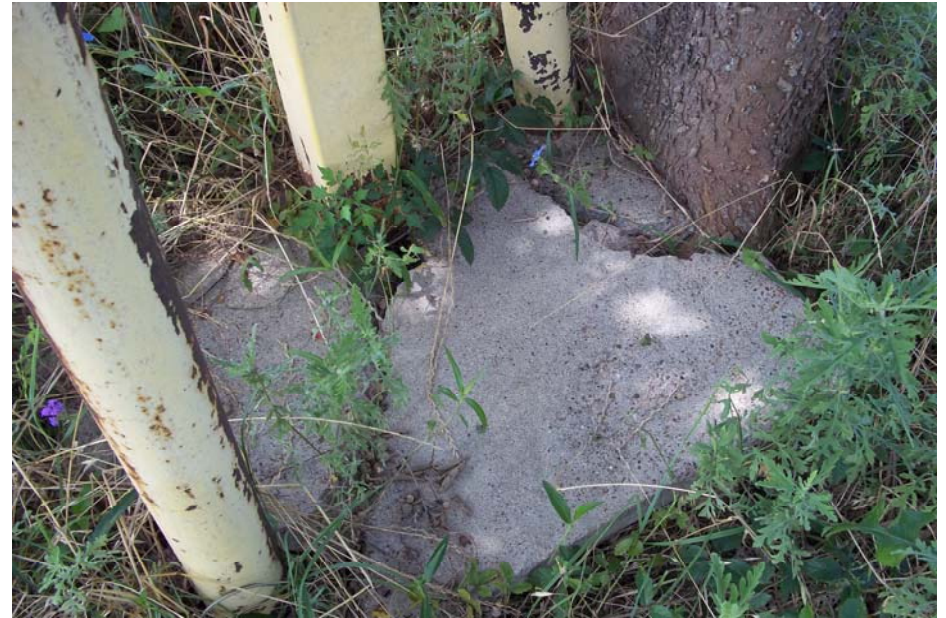
Photo 27. Northern area. The well pad for OW-16 is damaged and needs to be replaced.

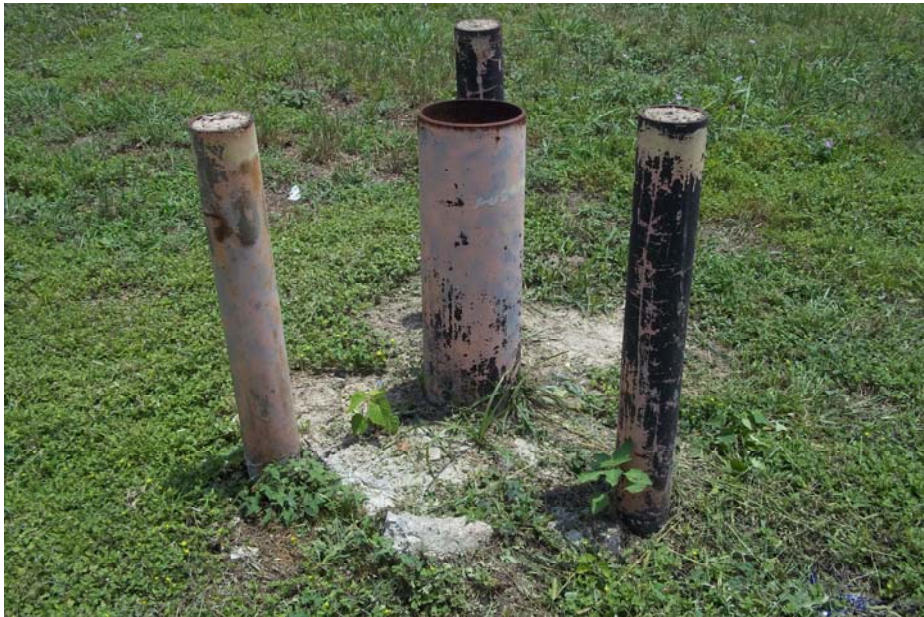
Photo 28. Off-site west of northern area. Unlabeled well in the area of MW-25.

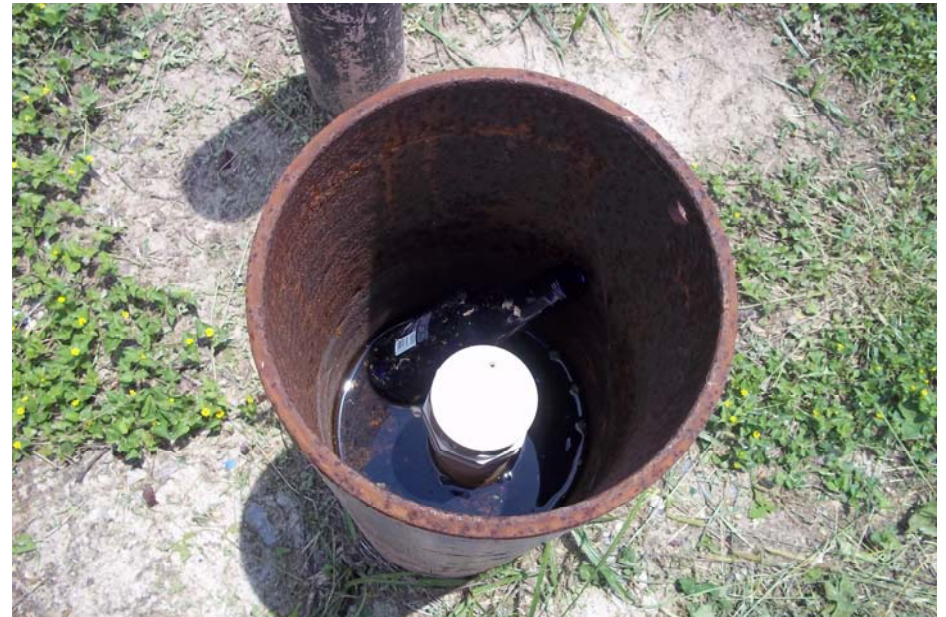
Photo 29. Off-site west of northern area. Unlabeled well in the area of MW-25 is missing the cover for the protective casing.
